# Performance Evaluation Test of the Rapid Area Preparation Tool (RAPTOR)

**December 2008**

Prepared by  
Institute for Defense Analyses  
4850 Mark Center Drive  
Alexandria, VA 22311-1882

**Humanitarian Demining Program**  
Night Vision and Electronic Sensors Directorate  
Attn: AMSRD-CER-NV-CM-HD  
10221 Burbeck Road  
Fort Belvoir, VA 22060

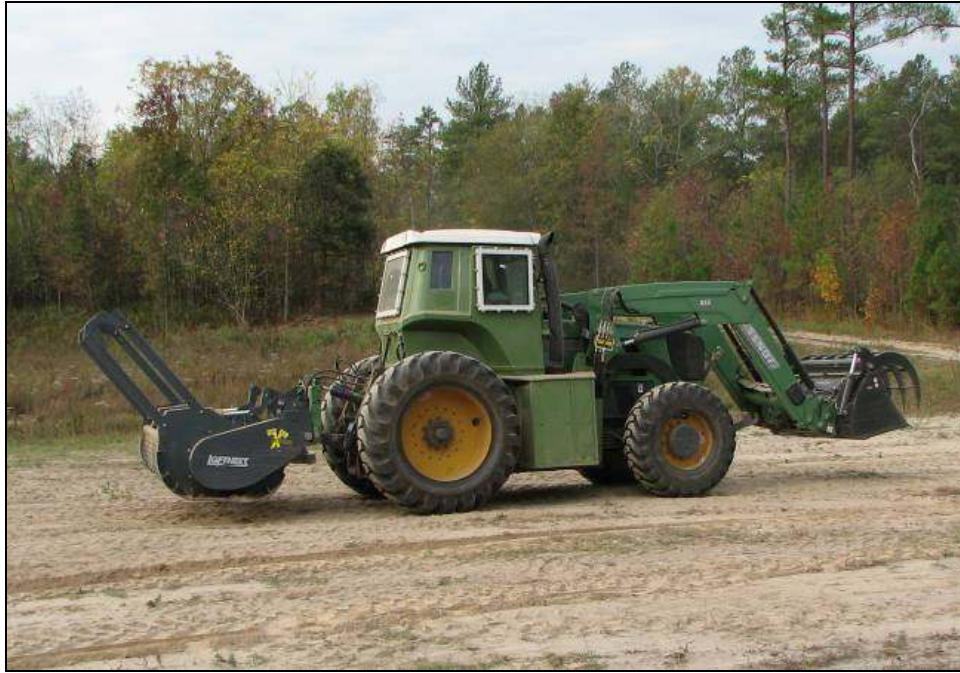
Figure 15: Loftness Vegetation Cutter

The Loftness vegetation cutter, shown in Figure 15 attached to the rear of the RAPTOR, is best operated at a forward speed of 1.5–3 kph. Operating speed depends on terrain (e.g., flat, rolling, etc.) and the category of vegetation being cut, where Category 1 vegetation allows for faster forward-moving speeds and Category 3–4 requires slower forward movement. For Category 3–4 vegetation cutting, it is recommended that the

RAPTOR's cruise control be used to ensure that vehicle speed and PTO rpm are maintained so that as much vegetation as possible is cut and mulched on one pass.

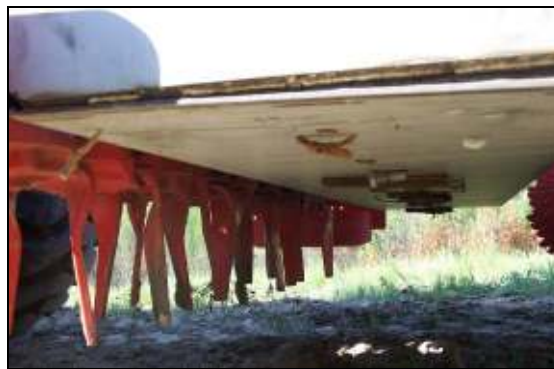
Figure 29 shows various metal objects (three steel plates, five metal bolts, two spikes), that were placed randomly on the surface or up to two inches below the surface of the soil in the test area in front of the RAPTOR's path to gauge the effectiveness of the harrow/magnet. After one emplacement of these items, all items recovered. In a second emplacement, all items except two bolts and one spike were recovered. Additional metal pieces were recovered from the test area. Before becoming a military installation, the test site was a privately owned farm and has since been used for training and testing. Additional metal recovered was mostly corroded metal scrap and objects that ranged in size from a few millimeters to several centimeters. One pass of the power harrow with magnet over the 5000 m<sup>2</sup> test area removed 402 pieces of metal clutter from the ground (see Figure 30). The test was completed in 158 minutes, a clearance rate of 1,898.7 m<sup>2</sup>/hr. Figures 31–34 are images of harrow/magnet operations.

**Figure 31: Power Harrow with Magnet Operations**

**Figure 32: Power Harrow with Magnet Operations**

**Figure 33: Metal Attracted to Magnet**

**Figure 34: Ground After Harrow/Magnet Operations**

Once the harrow and vehicle speeds were established, testing began in the plowed and cultivated test area at Test Site A. Pulling the harrow/magnet, the RAPTOR moved in straight lines down the test area, periodically dumping any collected metal at the test area boundaries.
